## Steam or Water Hammer

## Tube Damage from Steam Hammer

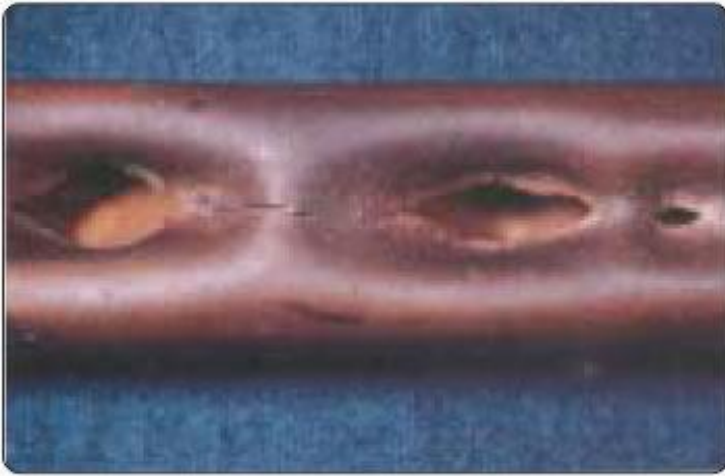
Pressure spikes, surges or shock waves as a result of a sudden and rapid acceleration or deceleration of any liquid can cause damaging steam or water hammer to the exchanger. Pressure surges have been seen in levels in excess of 20,000 psi, which would result in the complete rupture or collapse of the tubing of a heat exchanger. As an example, drawn copper  $\frac{3}{4}$  in x 20 BWG tubing typically has a rated burst pressure of 2100 psi, along with a collapse pressure of 600 psi

Pressure surges can be a result of an interruption in cooling water flow, stagnant water heated with a resulting generation of steam, or a resumption of flow producing steam. All these processes would likely cause a pressure surge, steam or water hammer. Therefore, the flow of the cooling fluid should always start prior to adding the heat load

Control valves that open or close suddenly to control fluid flow can produce water hammer. A modulating control valve is a preferable option to “on-off” types. A vacuum breaker vents are a must if the process involves a fluid that can or may condense on either the shell or tube side. Vacuum breakers prevent steam hammer from developing and causing damage as a result of condensate accumulation. Figure (B) is an example of typical tube damage caused by steam hammer. In the example provided, condensate accumulated in the shell rapidly, producing a high pressure shock wave that subsequently collapsed the tubes and caused multiple tear holes. Correctly sized steam traps with installed return lines pitched to a receiving container for condensate or a condensate return pump should be installed as to prevent such damage.
